F-8-126  
Fountain Rock Lime Co. Quarry & Housing Survey District Ca. 1870; 1900-1941

Walkersville, Maryland

Frederick County, Maryland

Survey No. F-8-126  
Fountain Rock Lime Quarry & Housing Survey District  
Walkersville, Maryland  
Frederick County, Maryland

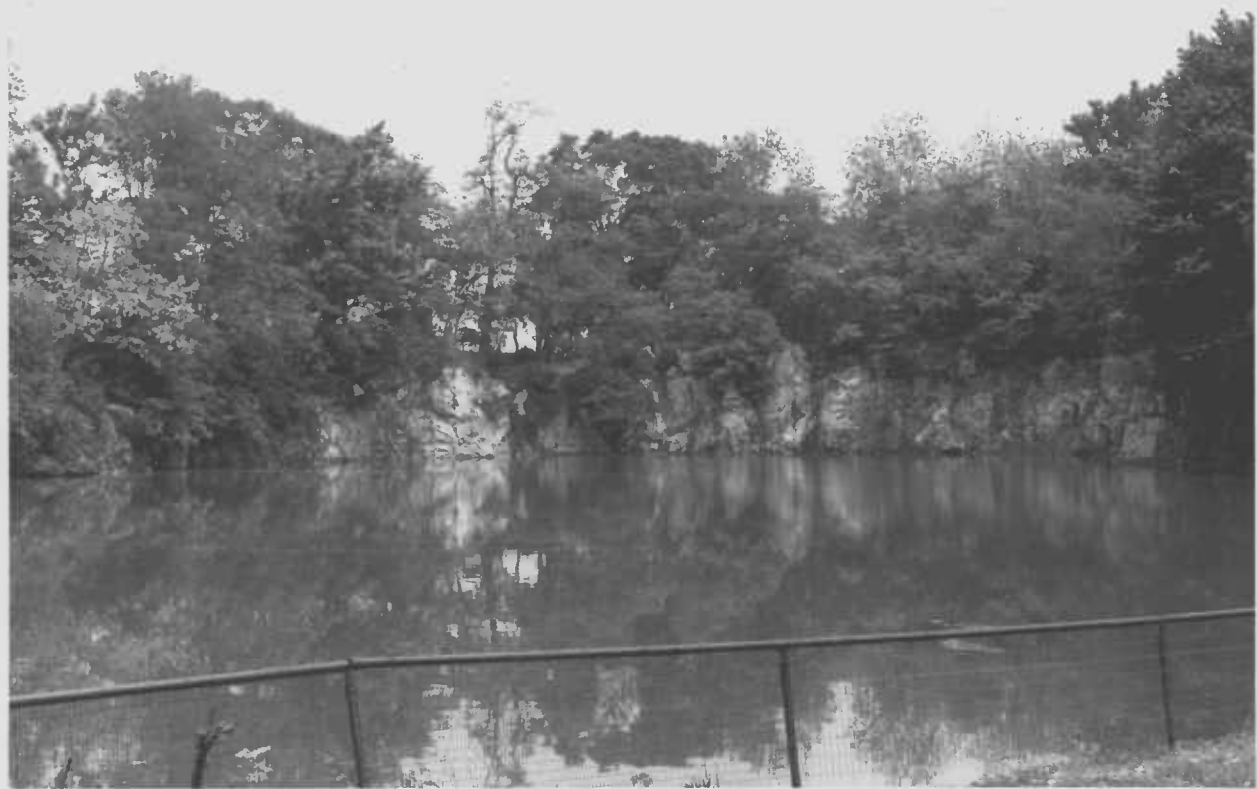
1/4

Quarry, general view

The two principal features of the Fountain Rock Survey District are the quarry pit and the lime kiln. The quarry is about 1 1/2 acres in area and about 30 ft. deep. The spring which fills the quarry was noted on the Titus 1873 Map of Frederick County prior to the establishment of the quarry and lime operations. In the 1950's, a trout fishery was established in the old quarry property and several trout ponds are scattered about the site, principally northwest of the quarry and the dwelling houses. The kiln is a single rectangular, flat-topped stack of rubble stone with three arched fire openings on the east and west elevations. The County Parks and Recreation Department's historical background information on the lime works states that the operations included eight ovens, two of which have collapsed. Their location is not known at the time of this survey. The stack is free-standing rather than built into a slope, due to the flat site of the quarry. The stone abutments, possibly foundations of the demolished stacks, just northwest of the kiln and the top of the kiln are overgrown with vegetation and grass, but the general outline of the kiln and the fire openings is cleared.

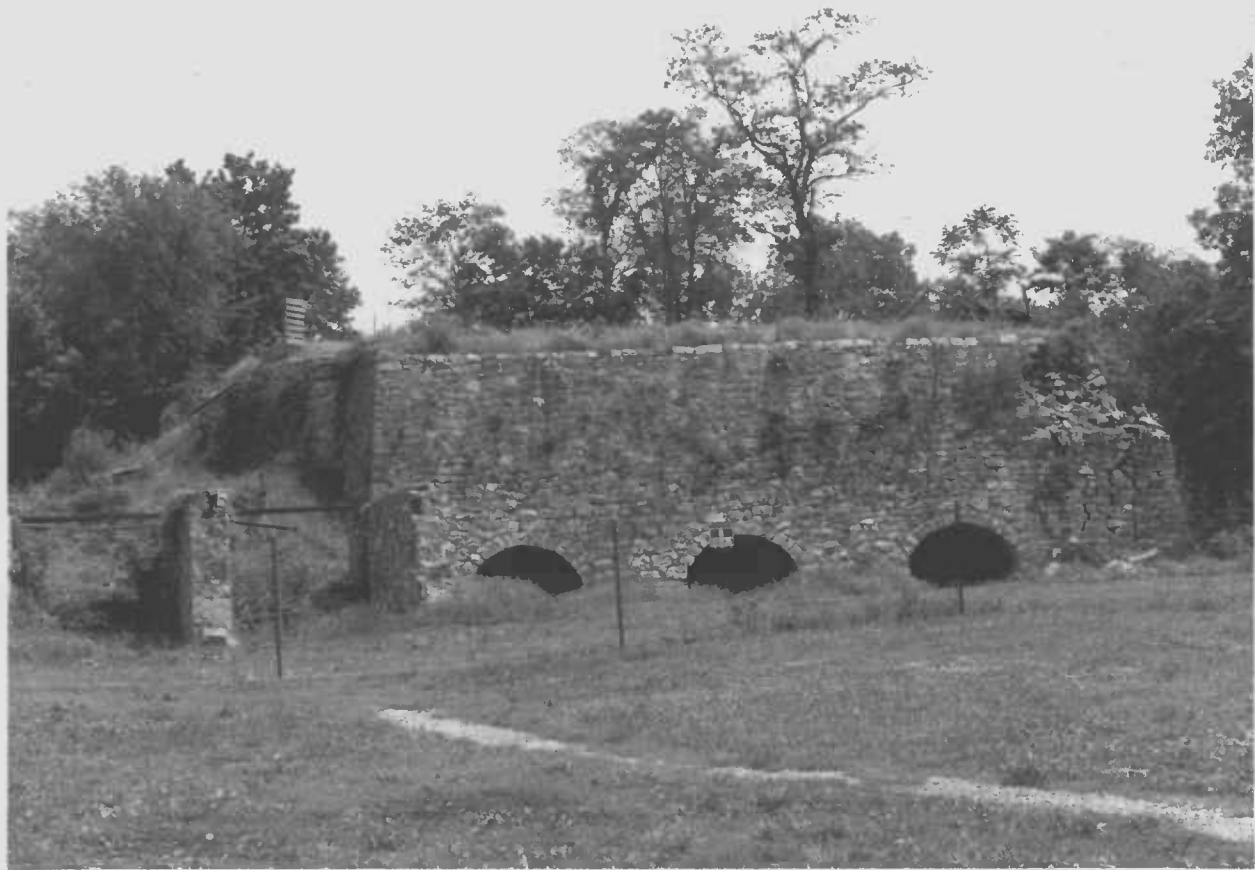
2/4

Lime Kiln, west elevation

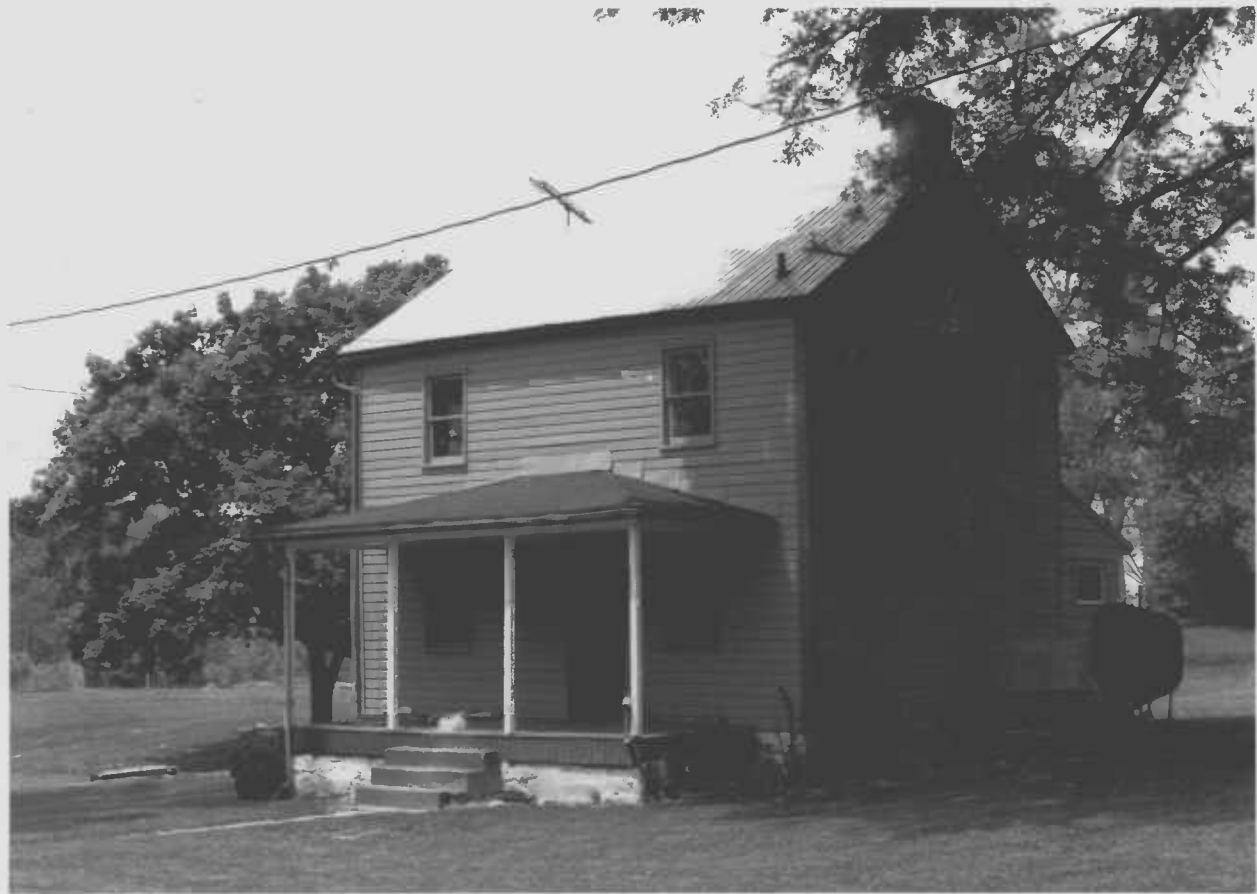
3/4

Log house, south elevation

The housing is clustered near the end of the access road in the southwest corner of the site. The log house and the non-contributing meeting house are located on the north side of the road facing the two frame dwelling houses on the south side. The log house is a two-story structure with three bays on the first floor and two on the second story. A one-story porch shelters the center entrance. The exterior is covered with german siding and the foundation is stone. The gable roof is covered by a standing seam roof. A single interior brick chimney rises from the east gable end. The windows are 1/1. The door has a glazed upper panel. The porch columns are narrow chamfered posts and the porch roof is covered with composition material. The rear elevation has a one-story shed addition with modern artificial siding. The building's log structure is apparent only by its general form and proportion. The Parks & Recreation Department's historical information identifies it as a log building, but does not date the structure. Since logs would be unusual in the first decade of the 20th century as a structural material, it is likely that the house was a farm structure shown on the 1873 Titus Map as "A. Diehl", one of several in the vicinity of the quarry site. Adam Diehl was the owner of several farms in the area at the time.

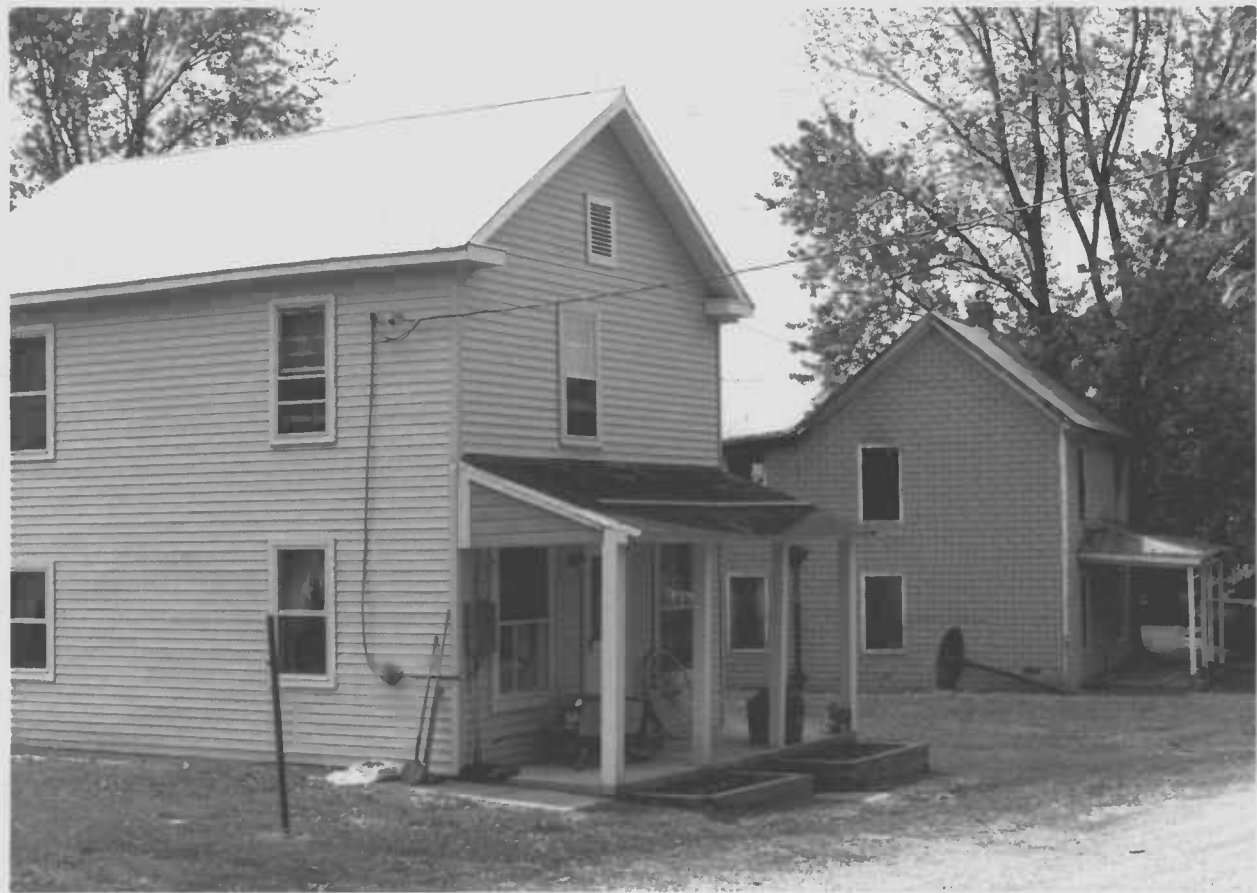
4/4

Frame houses, northeast corner view

The two frame houses on the south side of the road were probably built during the period 1900-1910. The westernmost has a similar plan and form to the log house, but is covered with composition siding. Many of the window openings are open or boarded and the sash appears to be missing. The house is unoccupied. The eastern house is occupied as the caretaker's quarters. It has a gable facade on the north side with a one-story porch and a three-bay first story elevation. The upper floor has only a single window on the north elevation. The exterior is covered with vinyl siding and the windows are 1/1 vinyl clad sash. The roof is standing seam metal.
